Manhole Inspection Summary

Manhole # S29GG_041MH

Insp Date: 1/2/07 9:29 AM

Location Address: **1617 JORDAN ST**

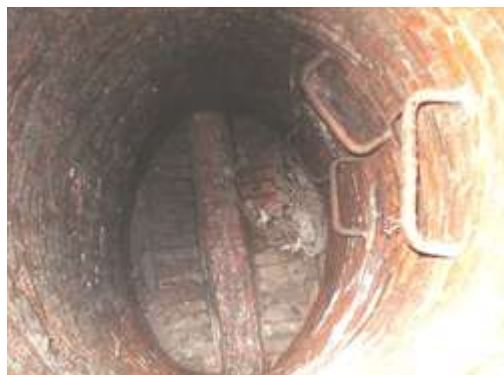
Top View

Corroded steps. Evidence of surcharge - Bench debris.

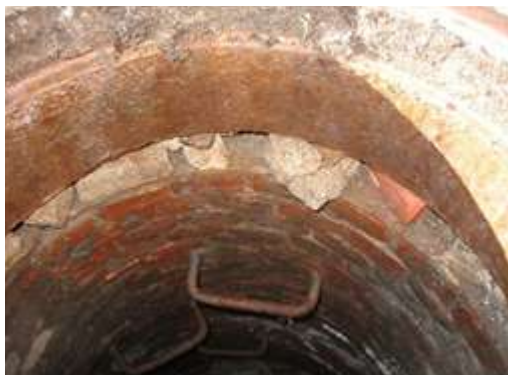
Defect

Frame leaks. Frame offset. Adjustment deterioration, loose brick and infiltration. Corbel infiltration.

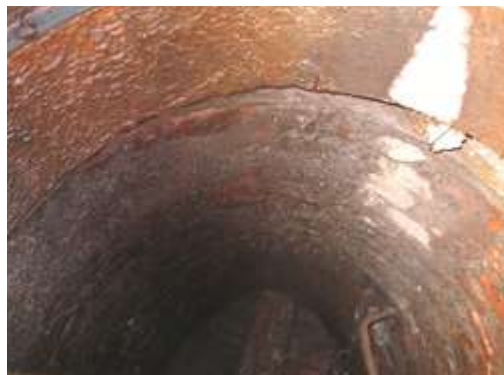
Defect

Frame leaks. Frame offset. Adjustment deterioration, loose brick and infiltration. Corbel infiltration - other side.

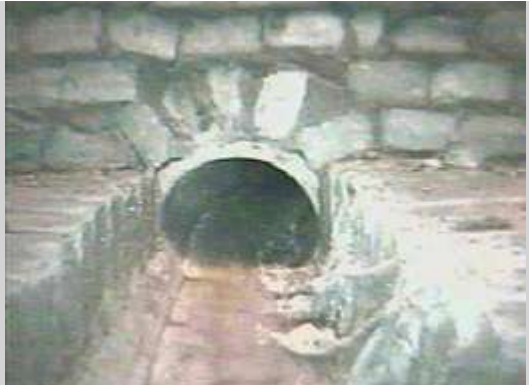
8 in. Circular Gravity Sewer Pipe Out @ 12 O'Clock

Barrel infiltration.

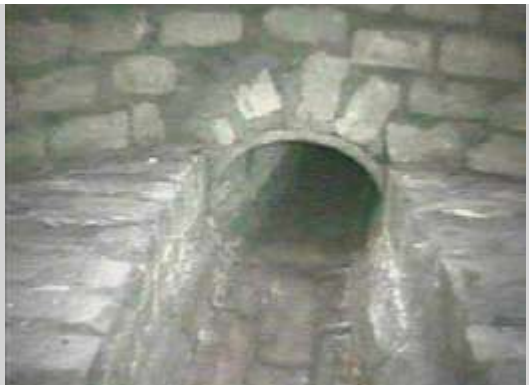
8 in. Circular Gravity Sewer Pipe In @ 6 O'Clock

Infiltration: **Evidence** Pipe Seal Cond: **Unknown**
